NEW MEXICO ENVIRONMENT DEPARTMENT

**Re: Desert Mountain Transportation, Inc. dba Desert Mountain Corporation; Kirtland, New Mexico;
Unpermitted MSGP; SIC 4213/NAICS 484121; Compliance Evaluation Inspection; NPDES
Tracking No. NMU001932; April 6, 2017**

NPDES Compliance Inspection Report

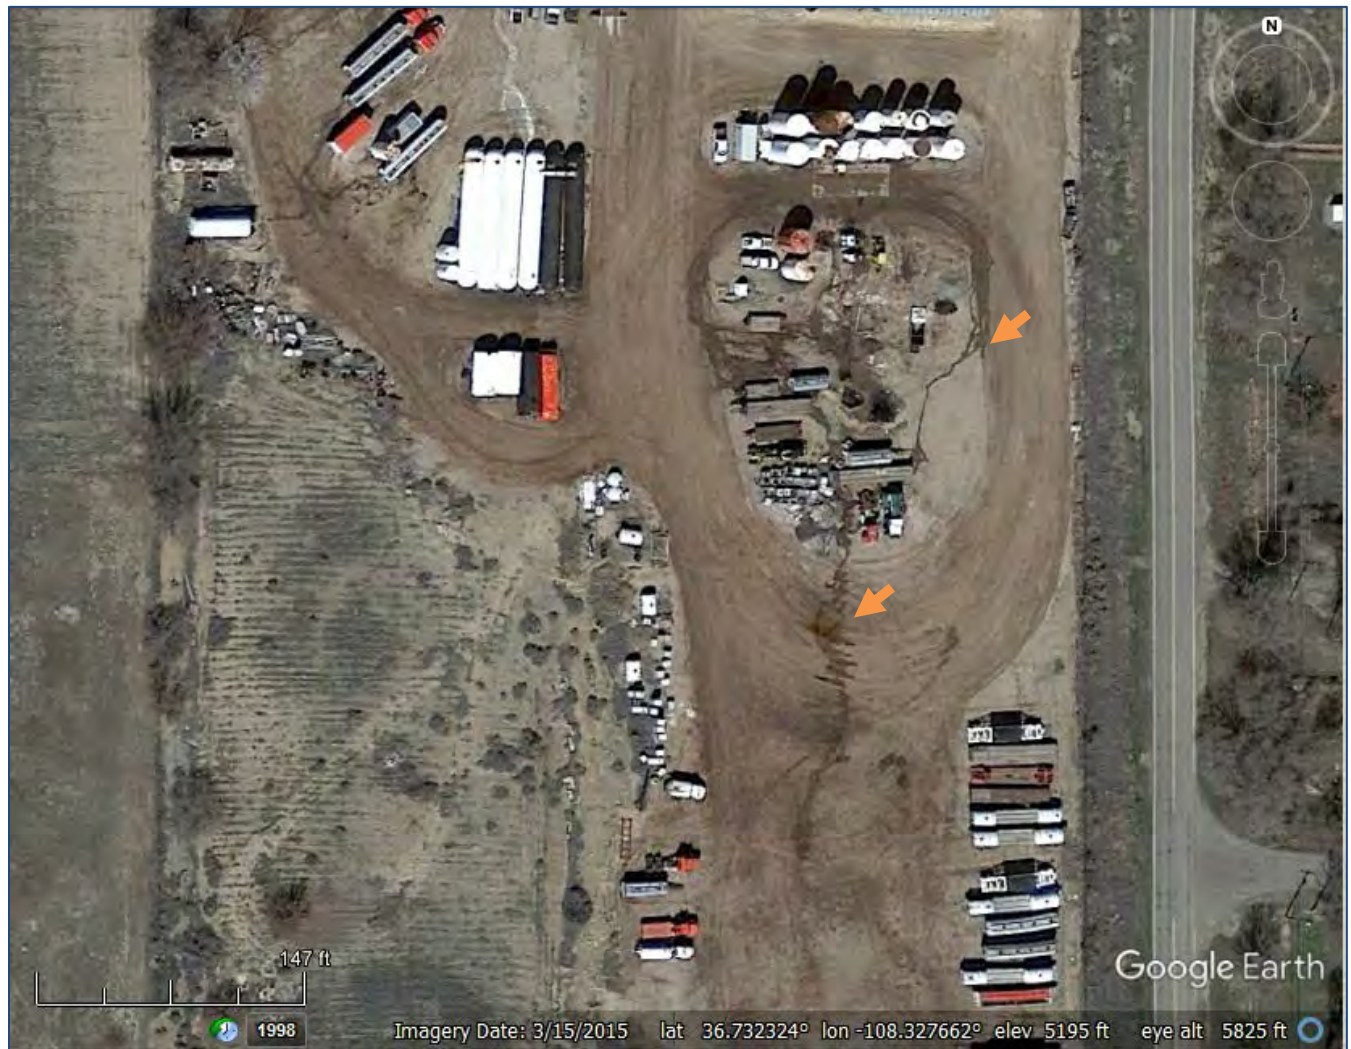
Figure 5 – Facility Image (Google Earth Imagery Date 03/15/2015)

Readily available on-line historic images of the facility are provided in Appendix C Figures 5 and 6. Dark brown features visible in 2011 and 2015 images of the site are similar to the dark brown lignin polymer solids and liquids on the ground surface observed during this CEI. Photos of example activities and potential pollutant sources observed during this CEI are provided in Appendix D. Additional information on the March 9-10, 2017, described approximately 18,000-gallon sodium salt lignin alkali spill, from local on-line newspaper, material information provided during this CEI, and follow up information provided to NMED SWQB on April 25 and 26, 2017 in Appendix E. Desert Mountain Corporation representatives described recovery of approximately 9,000 gallons of the spill, corrective action after the spill and proposed BMPs. for the site.

Note: Arrows points to example of dark brown features visible in 2015 image similar to dark brown lignin polymer solids and liquids observed during this CEI.

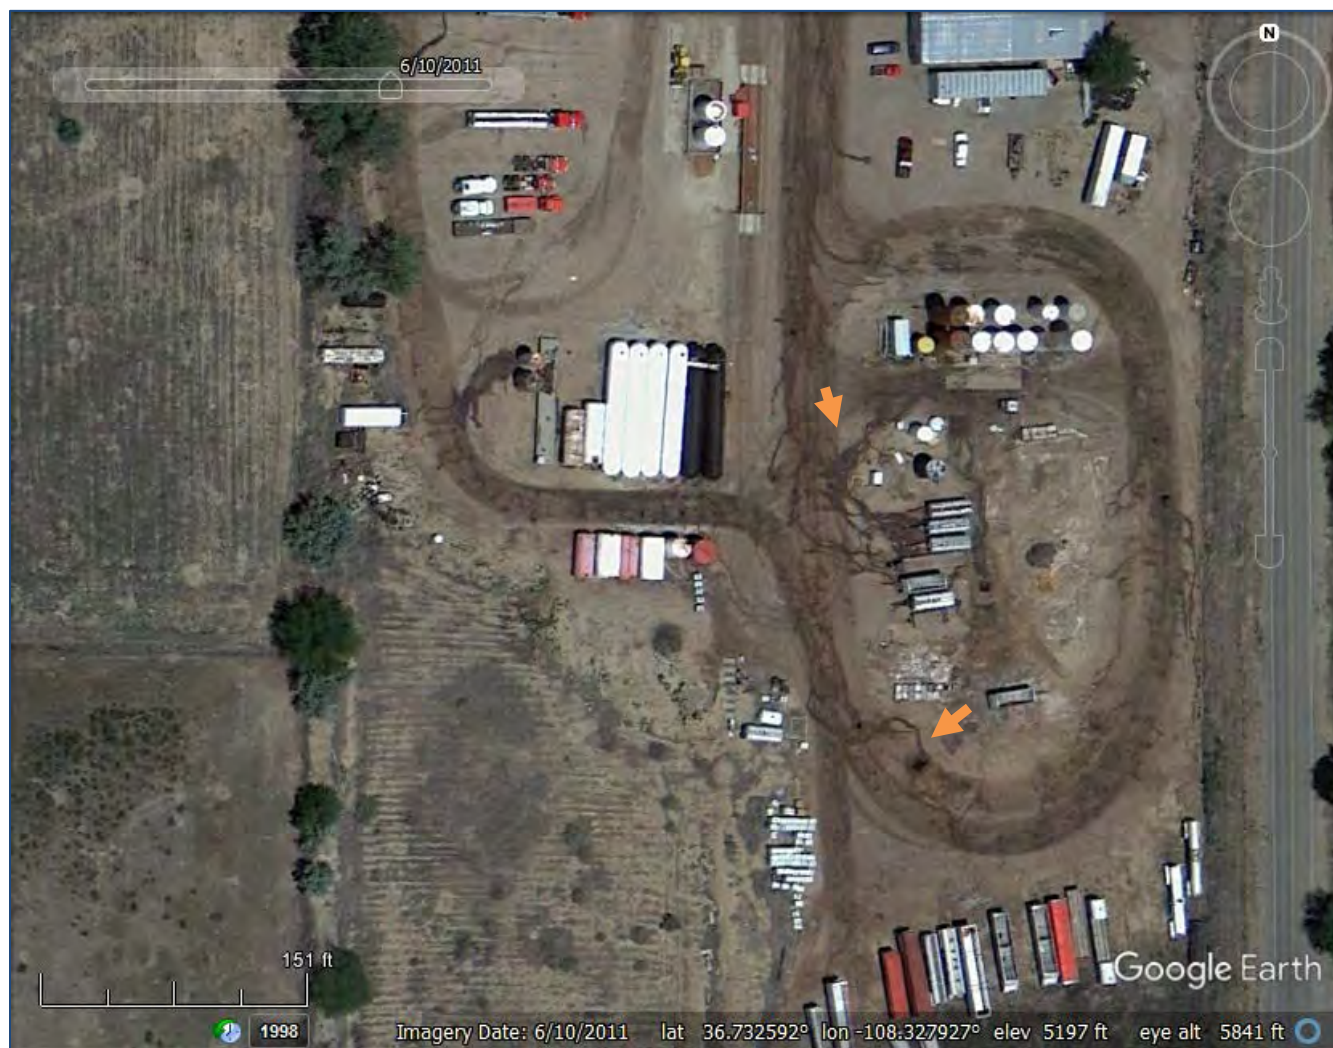
Figure 6 – Facility Image (Google Earth Imagery Date 06/10/2011)

Note: Arrows points to example of dark brown features visible in 2011 image similar to dark brown lignin polymer solids and liquids observed during this CEI.

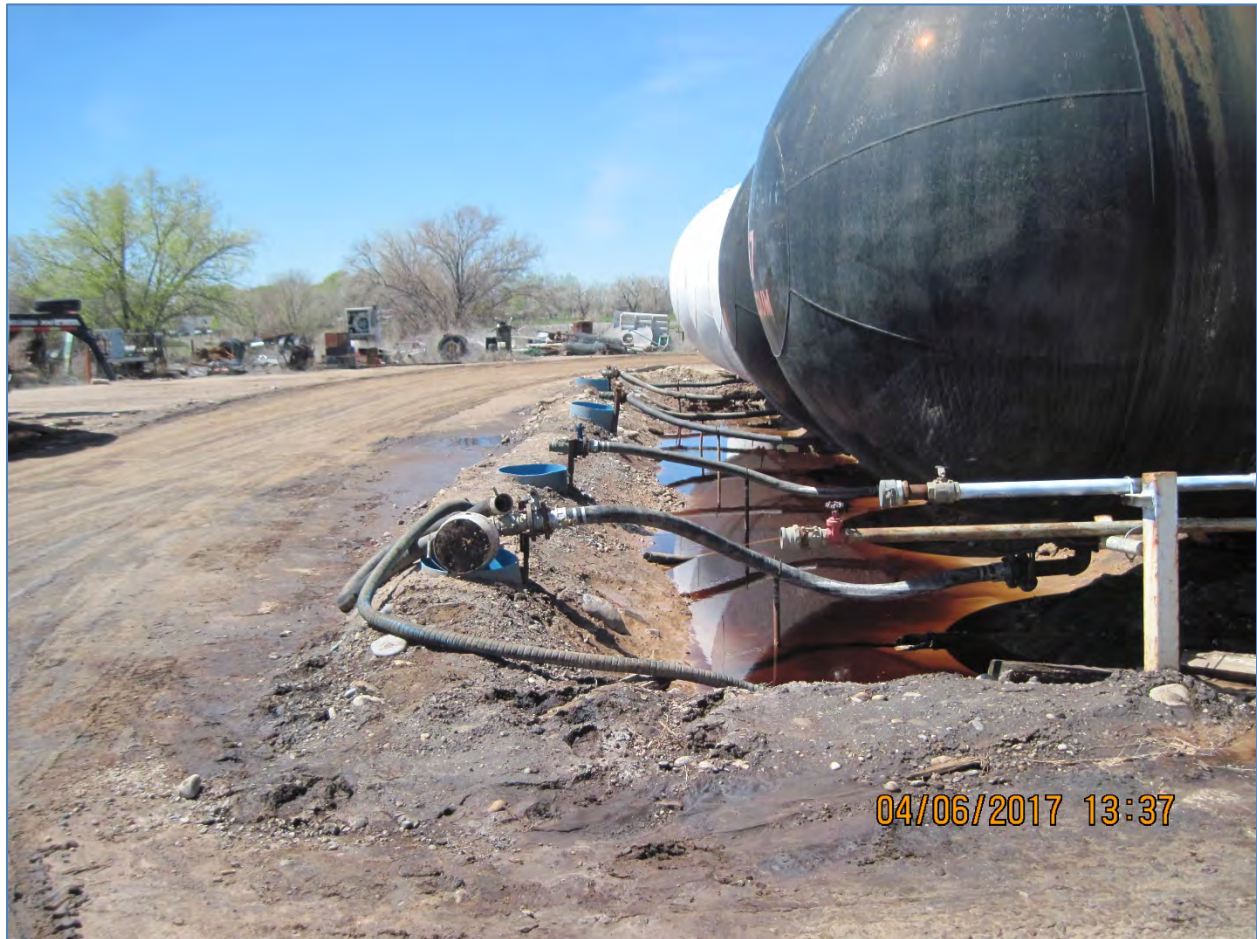
NMED/SWQB		
Official Photograph Log		
Photo # 1		
Photographer: Erin S. Trujillo	Date: 04/06/2017	Time: 1337 hours
City/County: Kirtland, New Mexico / San Juan County		State: New Mexico
Location: Desert Mountain Corporation		
Subject: From central portion of site looking west, the black above-ground storage tanks contained mixed salt liquid lignin dust suppressant according to operator representatives. Dark brown liquid was pooled below tanks. A valve leak and spill occurred from the second black tank on March 9-10, 2017 according to operator representatives.

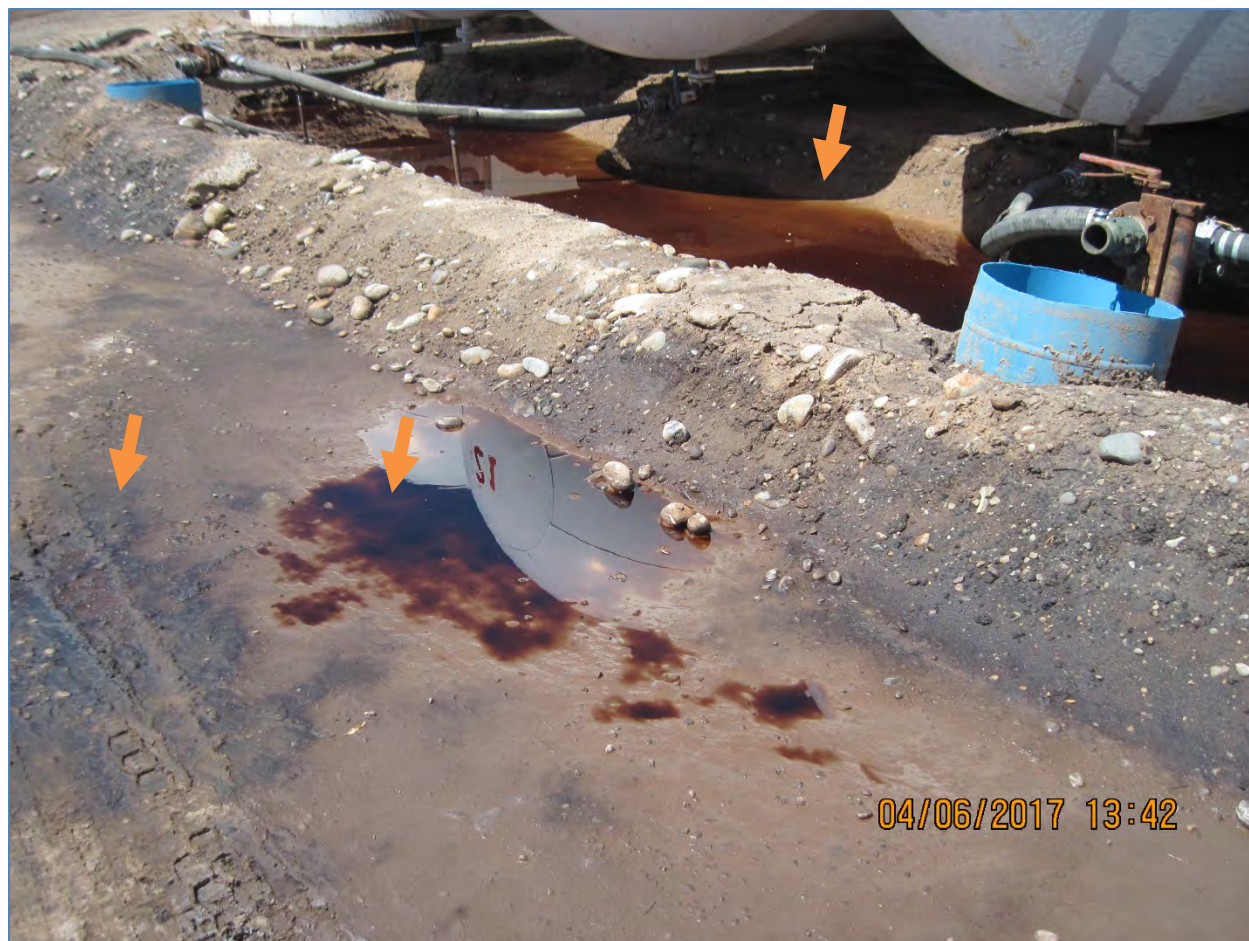
NMED/SWQB		
Official Photograph Log		
Photo # 2		
Photographer: Erin S. Trujillo	Date: 04/06/2017	Time: 1342 hours
City/County: Kirtland, New Mexico / San Juan County		State: New Mexico
Location: Desert Mountain Corporation		
Subject: Arrows point to dark brown liquid pooled below tanks shown in previous photo, and dark brown polymer product and liquids outside berm.

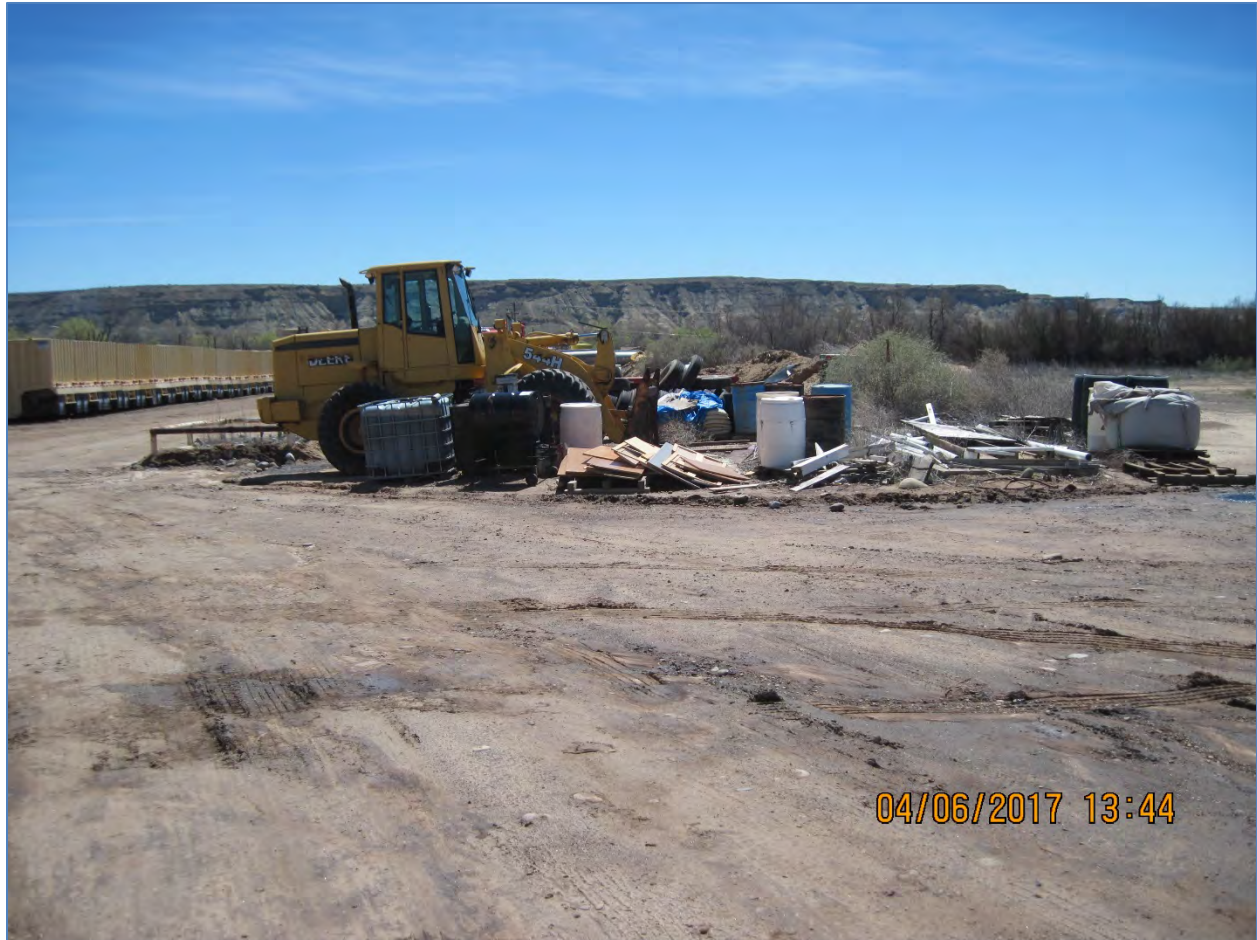
NMED/SWQB Official Photograph Log Photo # 3		
Photographer: Erin S. Trujillo	Date: 04/06/2017	Time: 1344 hours
City/County: Kirtland, New Mexico / San Juan County		State: New Mexico
Location: Desert Mountain Corporation		
Subject: From central portion of site looking south, examples of facility metal, pallets, drums, totes and equipment storage.

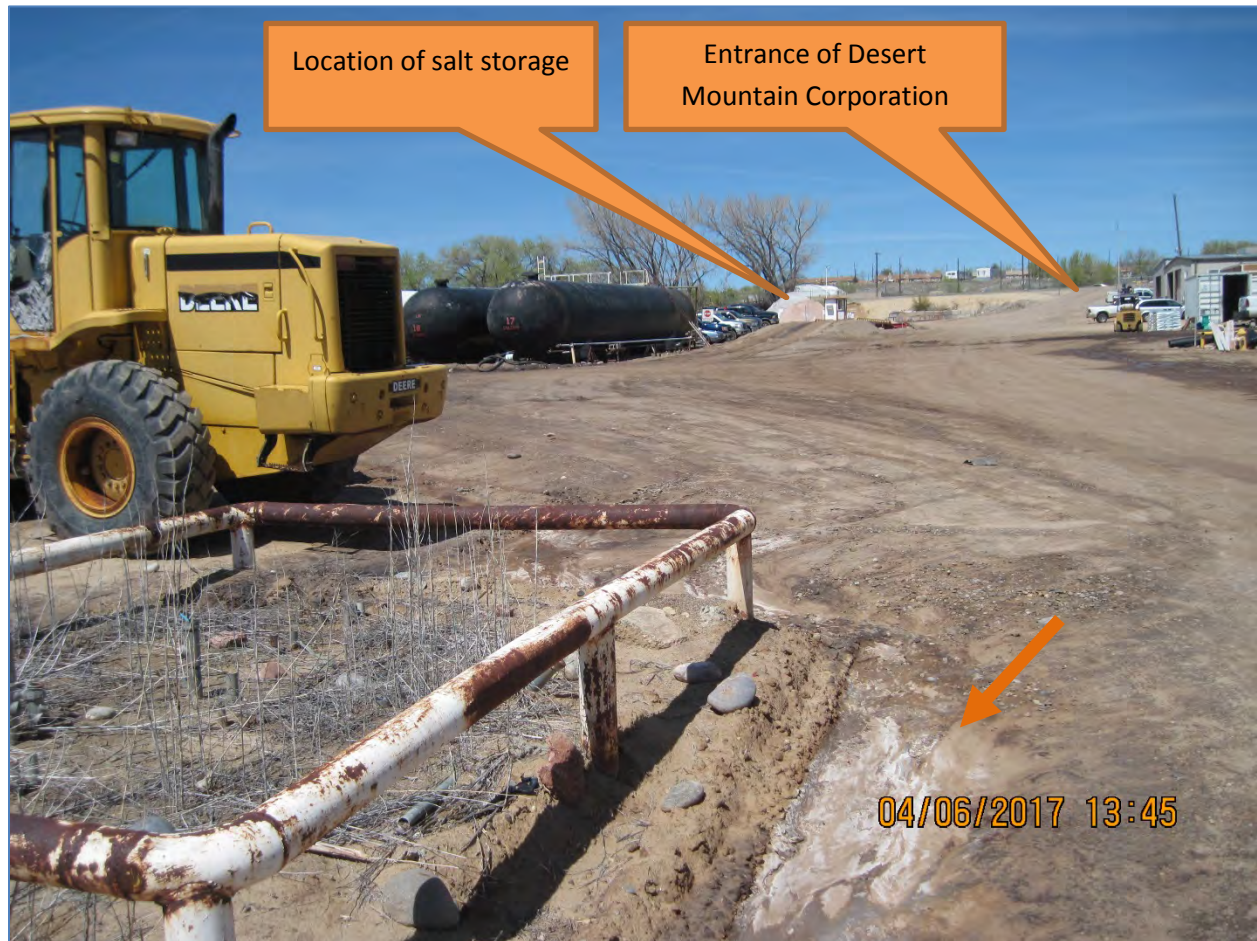
NMED/SWQB Official Photograph Log Photo # 4		
Photographer: Erin S. Trujillo	Date: 04/06/2017	Time: 1345 hours
City/County: Kirtland, New Mexico / San Juan County		State: New Mexico
Location: Desert Mountain Corporation		
Subject: From central portion of site looking north, arrow in foreground of photo points to example of white residue in shallow drainage rill on site. Callout shows location of facility entrance and salt storage near facility entrance.

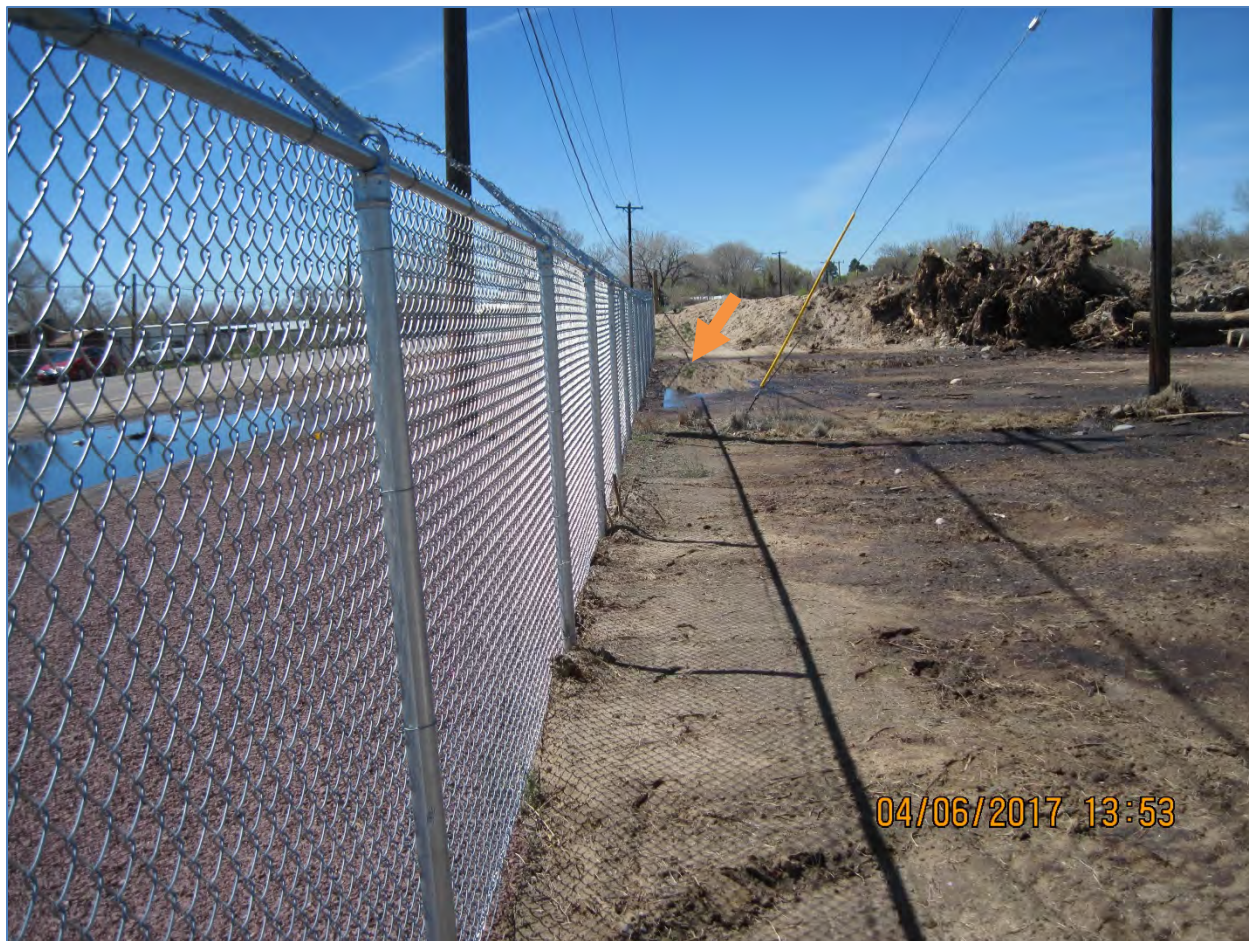
NMED/SWQB		
Official Photograph Log		
Photo # 5		
Photographer: Erin S. Trujillo	Date: 04/06/2017	Time: 1353 hours
City/County: Kirtland, New Mexico / San Juan County		State: New Mexico
Location: Desert Mountain Corporation		
Subject: From southern boundary of site looking west, dark brown solids and liquids were observed along facility's fence. Arrow points to pooled liquid inside fence.

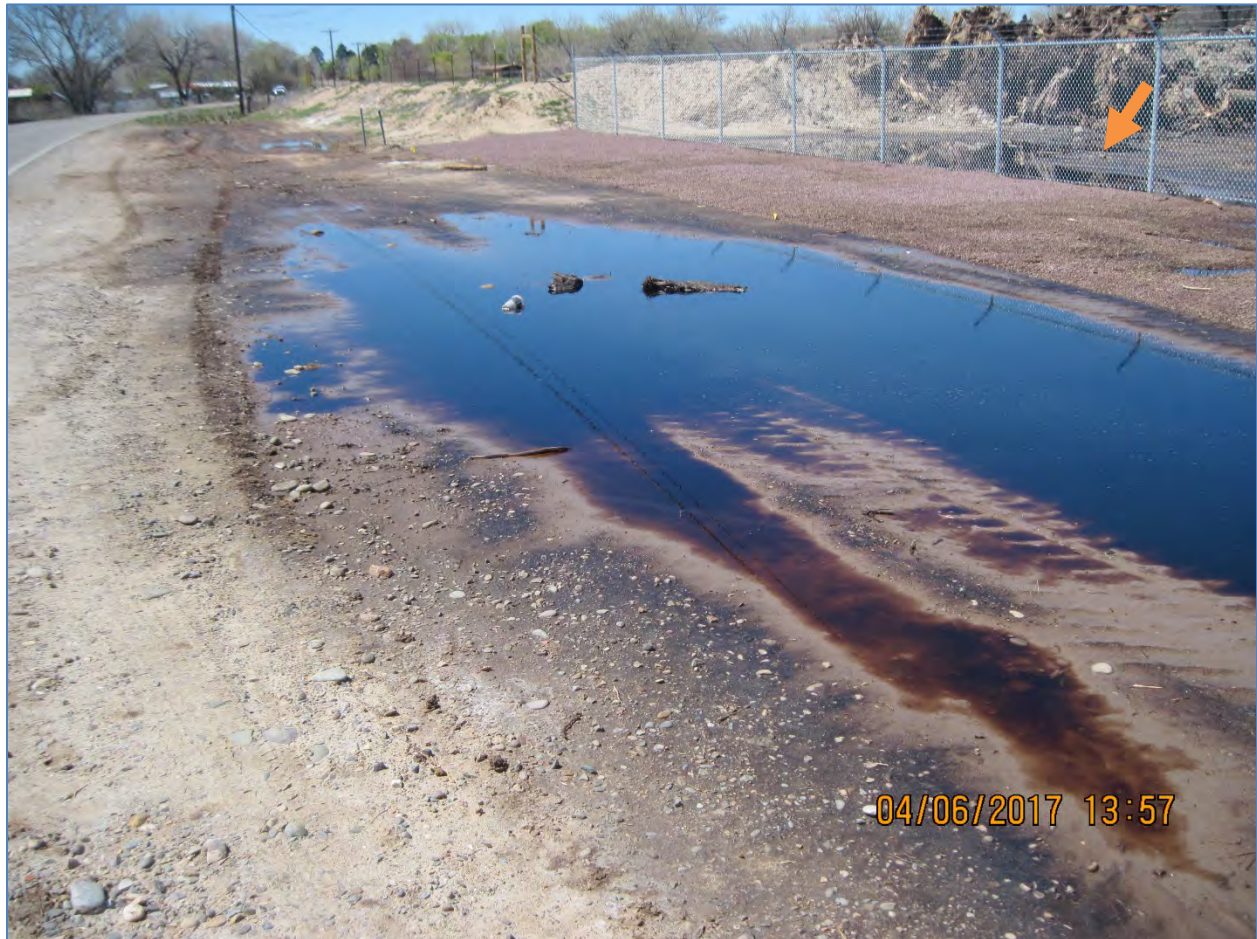
NMED/SWQB Official Photograph Log Photo # 6		
Photographer: Erin S. Trujillo	Date: 04/06/2017	Time: 1357 hours
City/County: Kirtland, New Mexico / San Juan County		State: New Mexico
Location: Desert Mountain Corporation		
Subject: Looking west, dark brown solids and liquid existed on CR 6100 right of way. Arrow points dark brown liquid inside facility's fence shown in previous photo. Landscape rock outside fence was installed after the spill according to operator representatives.

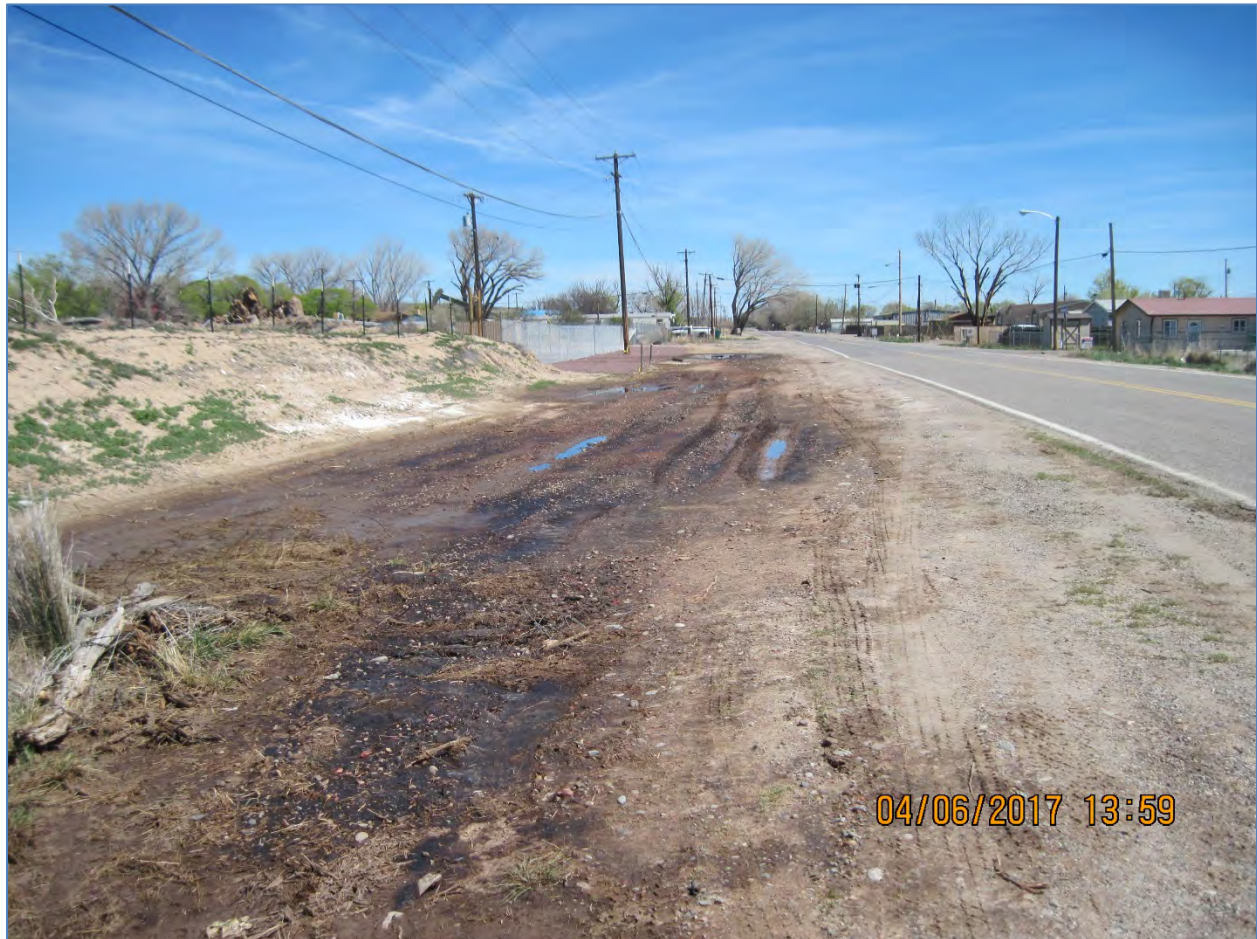
NMED/SWQB		
Official Photograph Log		
Photo # 7		
Photographer: Erin S. Trujillo	Date: 04/06/2017	Time: 1359 hours
City/County: Kirtland, New Mexico / San Juan County		State: New Mexico
Location: Desert Mountain Corporation		
Subject: Looking east, dark brown solids and liquid that appear to be from spill remain on CR 6100 right of way.

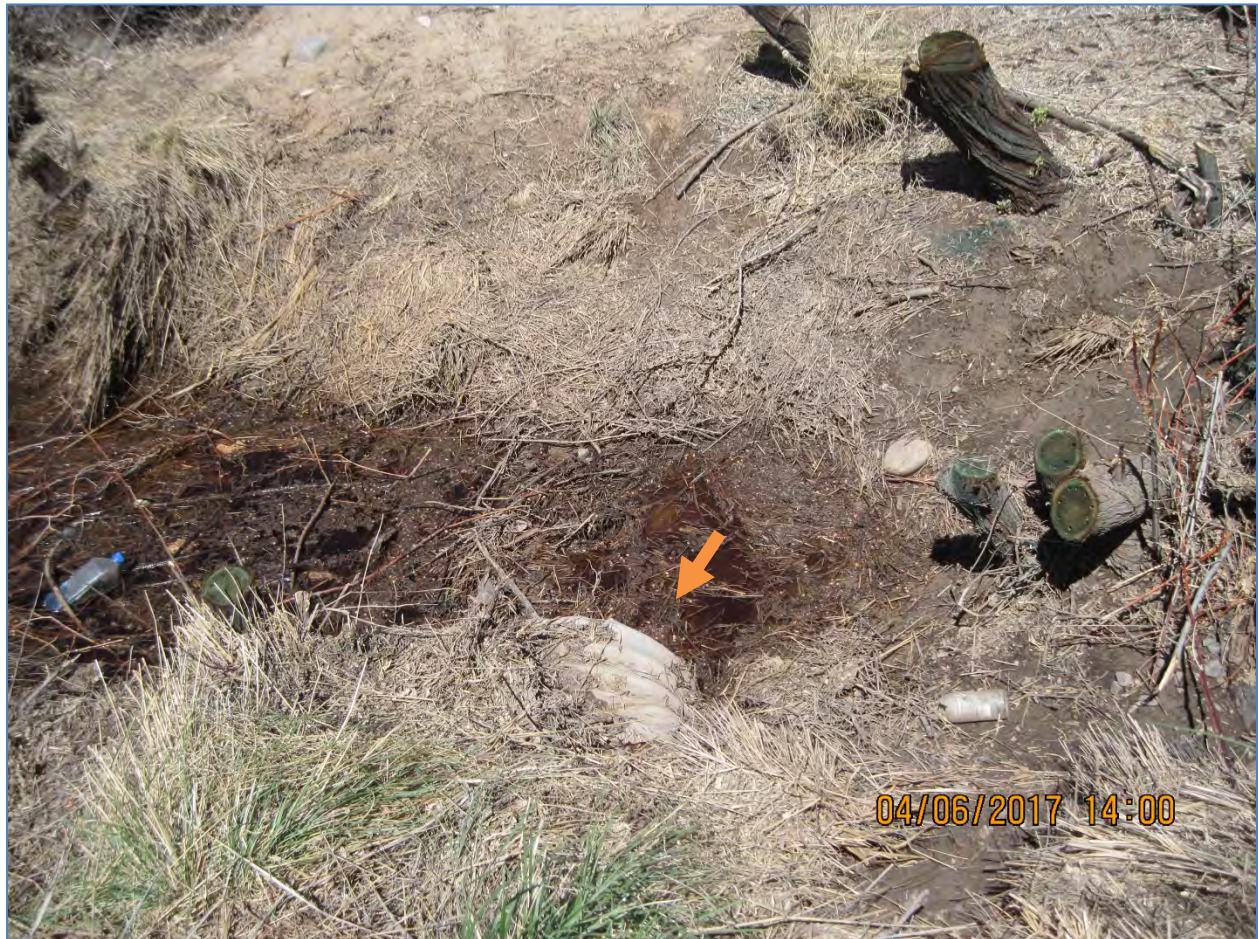
NMED/SWQB		
Official Photograph Log		
Photo # 8		
Photographer: Erin S. Trujillo	Date: 04/06/2017	Time: 1400 hours
City/County: Kirtland, New Mexico / San Juan County		State: New Mexico
Location: Desert Mountain Corporation		
Subject: West of facility, dark brown liquid was in north drainage ditch on CR 6100 right of way. Arrow points to culvert that crosses beneath CR 6100. Culvert appears to connect both ditches along CR 6100.

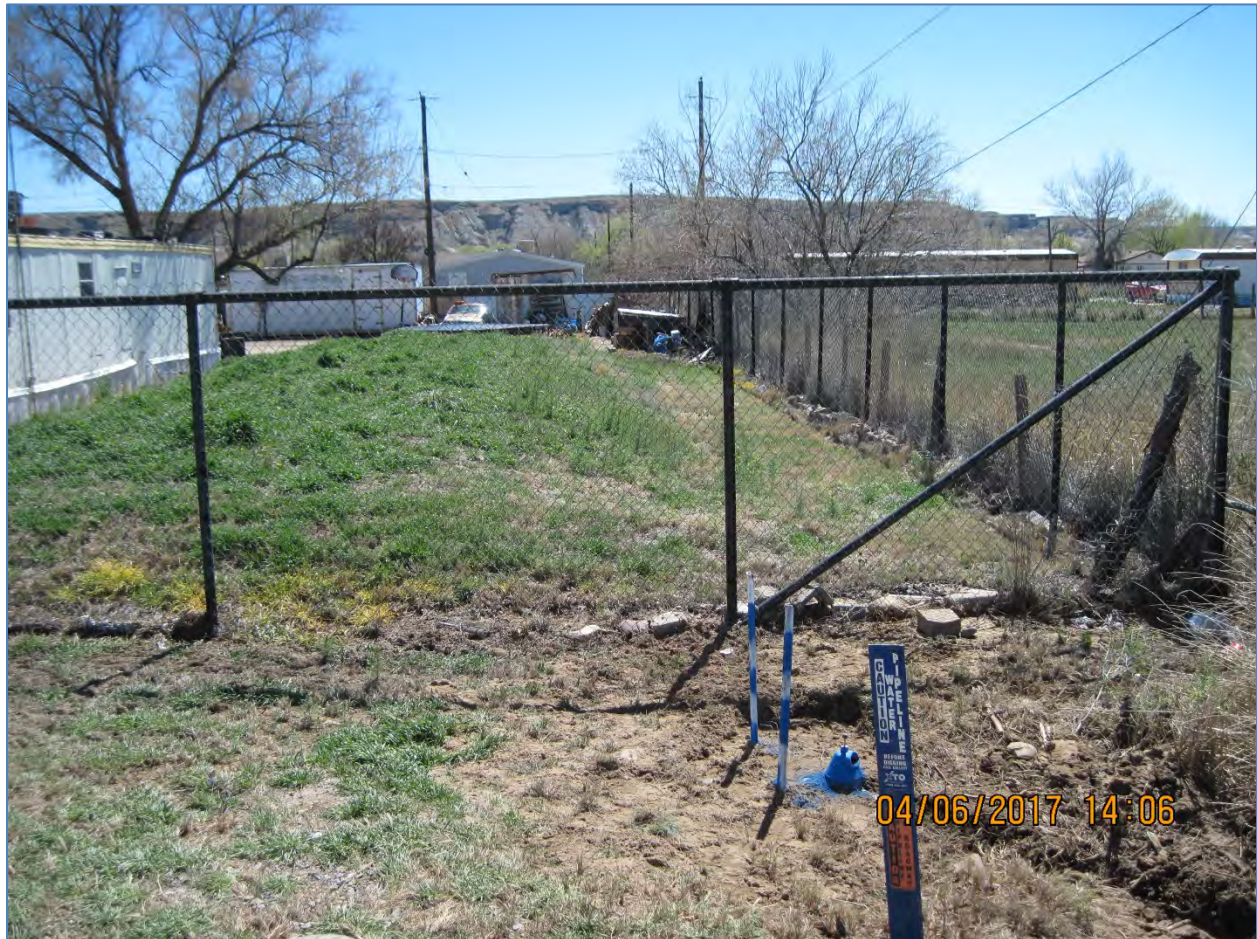
NMED/SWQB		
Official Photograph Log		
Photo # 9		
Photographer: Erin S. Trujillo	Date: 04/06/2017	Time: 1406 hours
City/County: Kirtland, New Mexico / San Juan County		State: New Mexico
Location: Desert Mountain Corporation		
Subject: West of facility from CR 6100 right of way, looking south, the blue utility delineator shown in this photo is near the location of a partially buried end of culvert that was shown in previous photo.

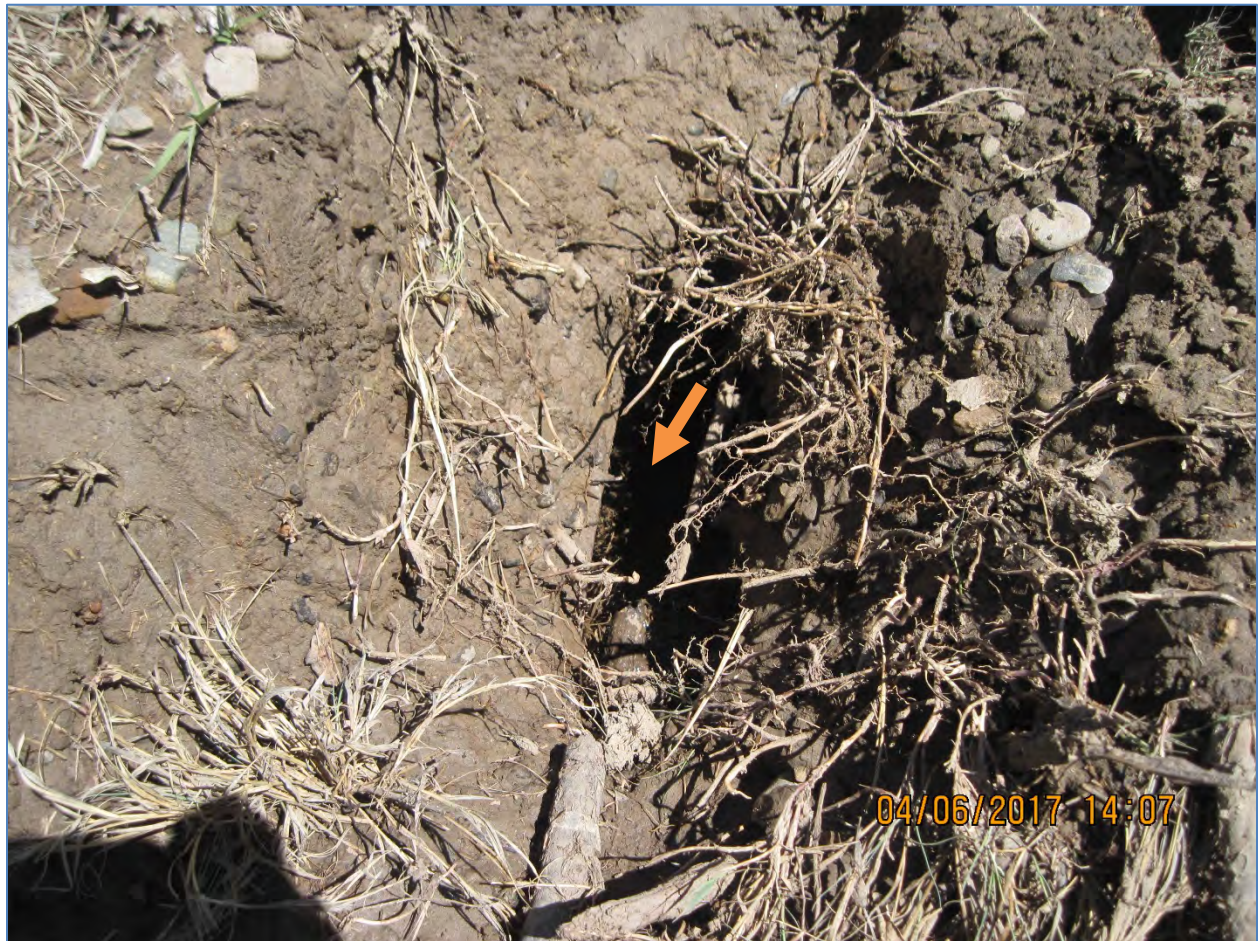
NMED/SWQB		
Official Photograph Log		
Photo # 10		
Photographer: Erin S. Trujillo	Date: 04/06/2017	Time: 1407 hours
City/County: Kirtland, New Mexico / San Juan County		State: New Mexico
Location: Desert Mountain Corporation		
Subject: Arrow points to partially buried end of culvert on southside of CR 6100. Although not discernable in photo, brown liquid was observed at the culvert end.

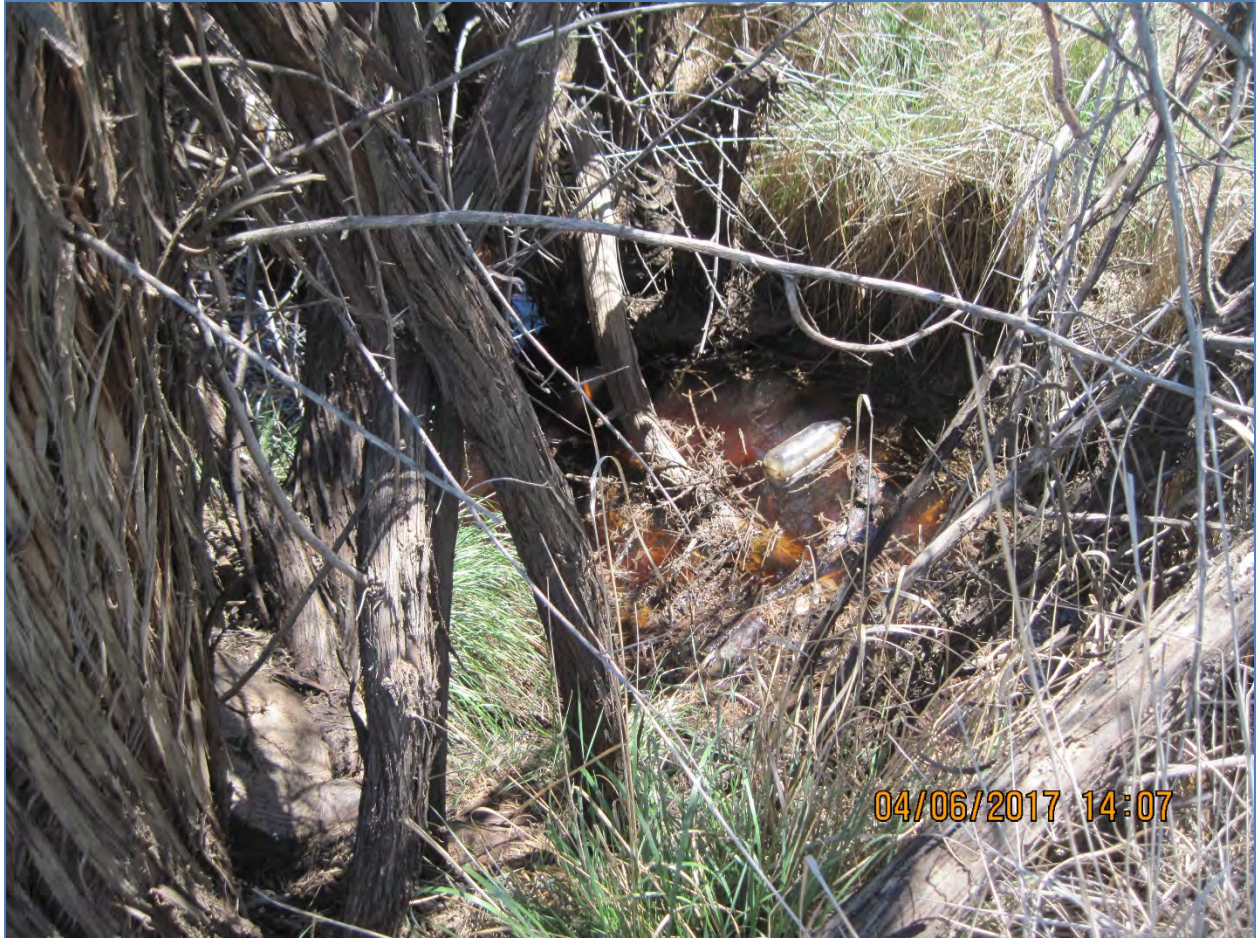
NMED/SWQB		
Official Photograph Log		
Photo # 11		
Photographer: Erin S. Trujillo	Date: 04/06/2017	Time: 1407 hours
City/County: Kirtland, New Mexico / San Juan County		State: New Mexico
Location: Desert Mountain Corporation		
Subject: West of facility looking south, dark brown liquid was observed in south drainage ditch on CR 6100 right of way west of previous photo.

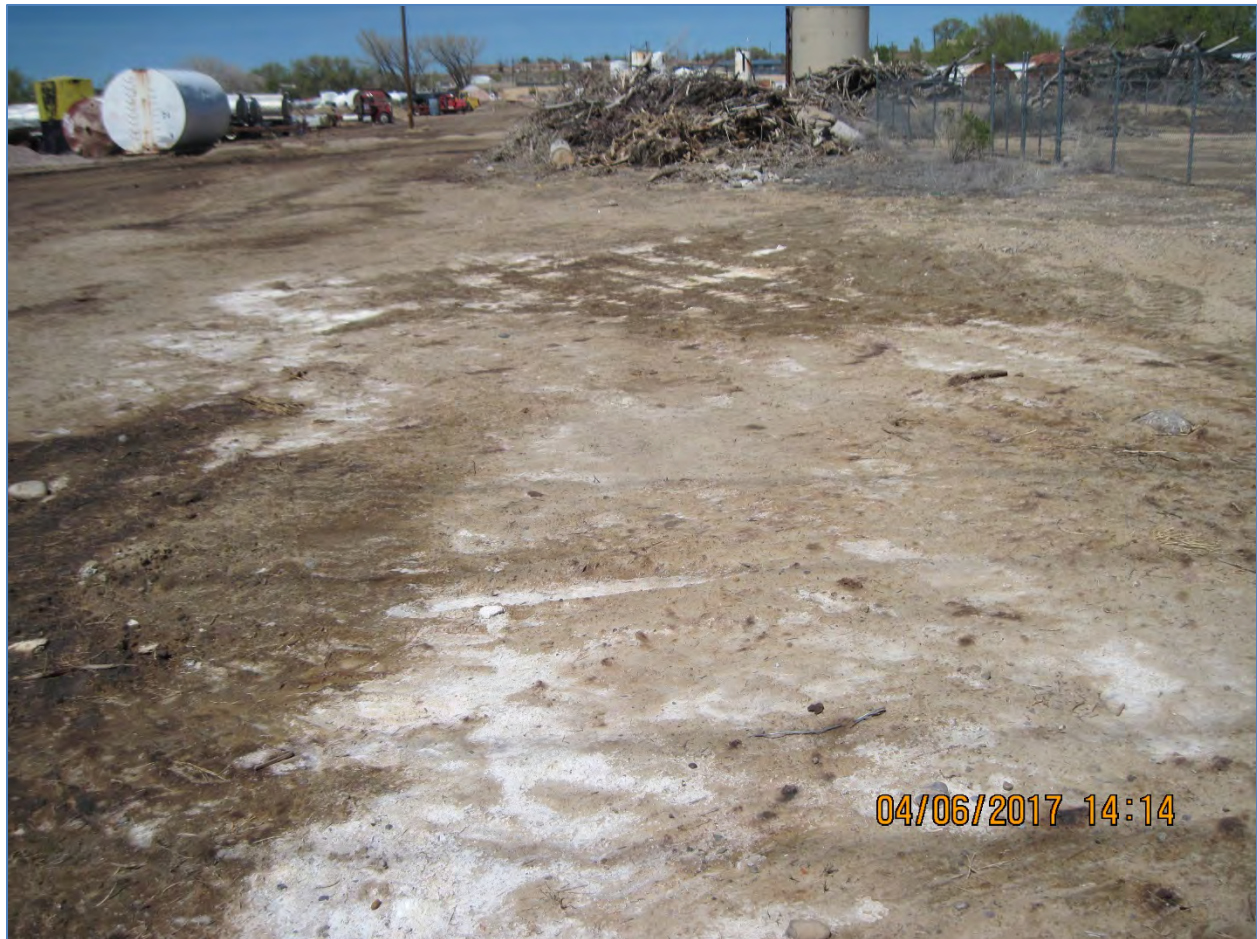
NMED/SWQB		
Official Photograph Log		
Photo # 12		
Photographer: Erin S. Trujillo	Date: 04/06/2017	Time: 1414 hours
City/County: Kirtland, New Mexico / San Juan County		State: New Mexico
Location: Desert Mountain Corporation		
Subject: Inside facility, looking north, white residue and dark solids existed on the ground surface in southern portion of site.

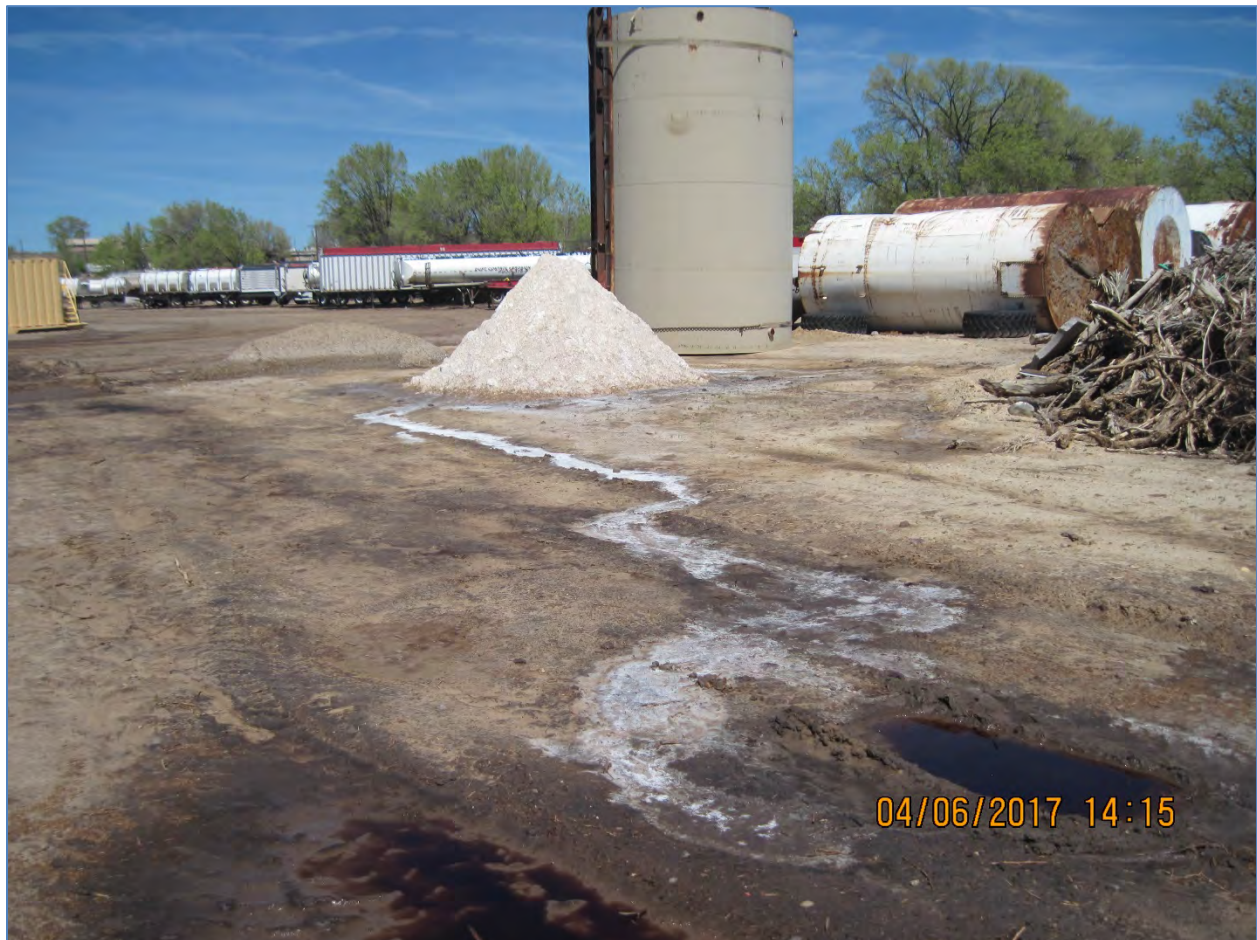
NMED/SWQB Official Photograph Log Photo # 13		
Photographer: Erin S. Trujillo	Date: 04/06/2017	Time: 1415 hours
City/County: Kirtland, New Mexico / San Juan County		State: New Mexico
Location: Desert Mountain Corporation		
Subject: North of previous photo, looking northeast, piled salt was from product tank cleaning according to operator representative. White residue from the piled salt continues south along shallow rill. Dark brown solids and liquid in foreground of photo may be from spill or stormwater runoff.

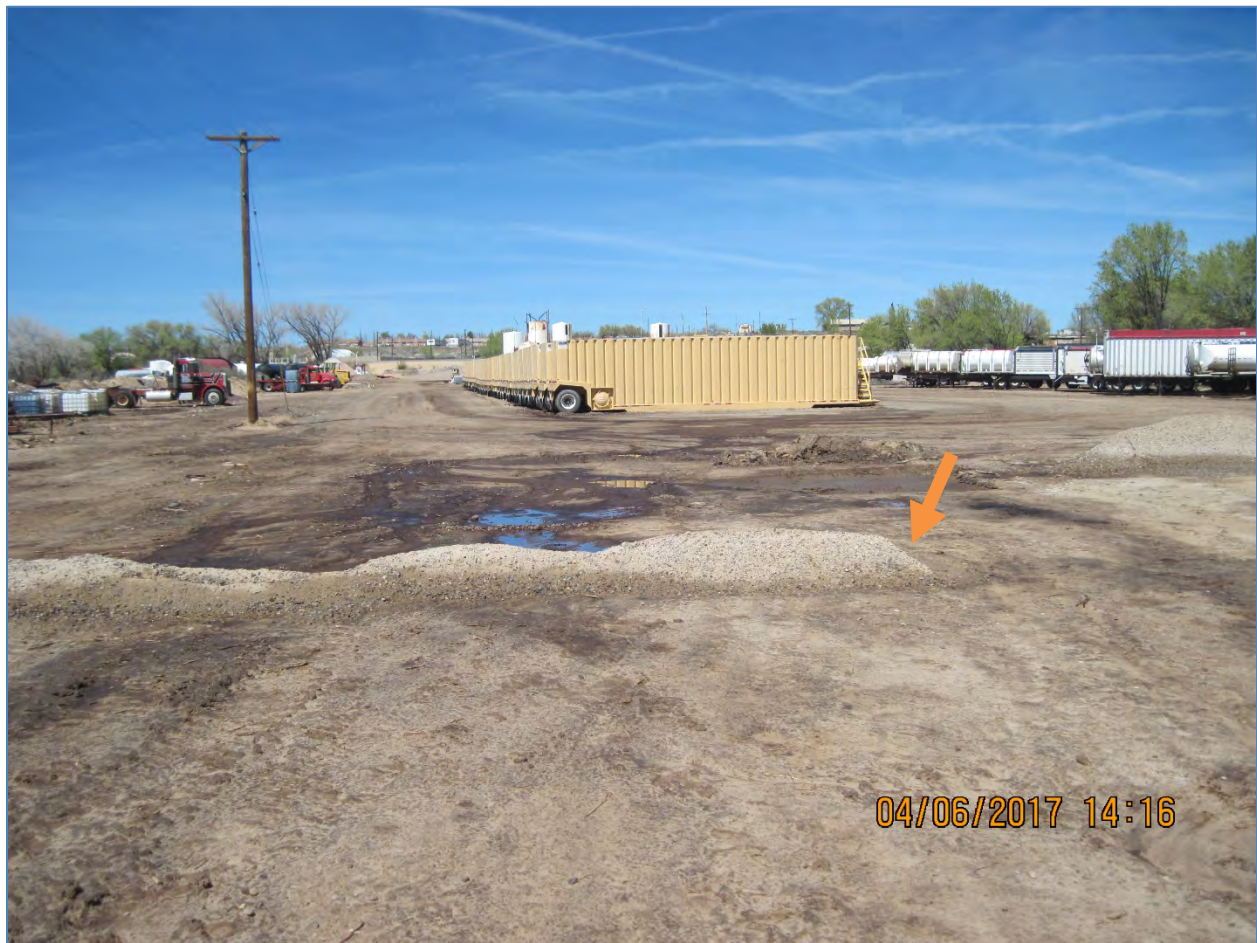
NMED/SWQB		
Official Photograph Log		
Photo # 14		
Photographer: Erin S. Trujillo	Date: 04/06/2017	Time: 1416 hours
City/County: Kirtland, New Mexico / San Juan County		State: New Mexico
Location: Desert Mountain Corporation		
Subject: Looking north, arrow points to shallow earthen and aggregate berm placed after the spill according to the operator representatives. The berm did not continue across entire site boundary.

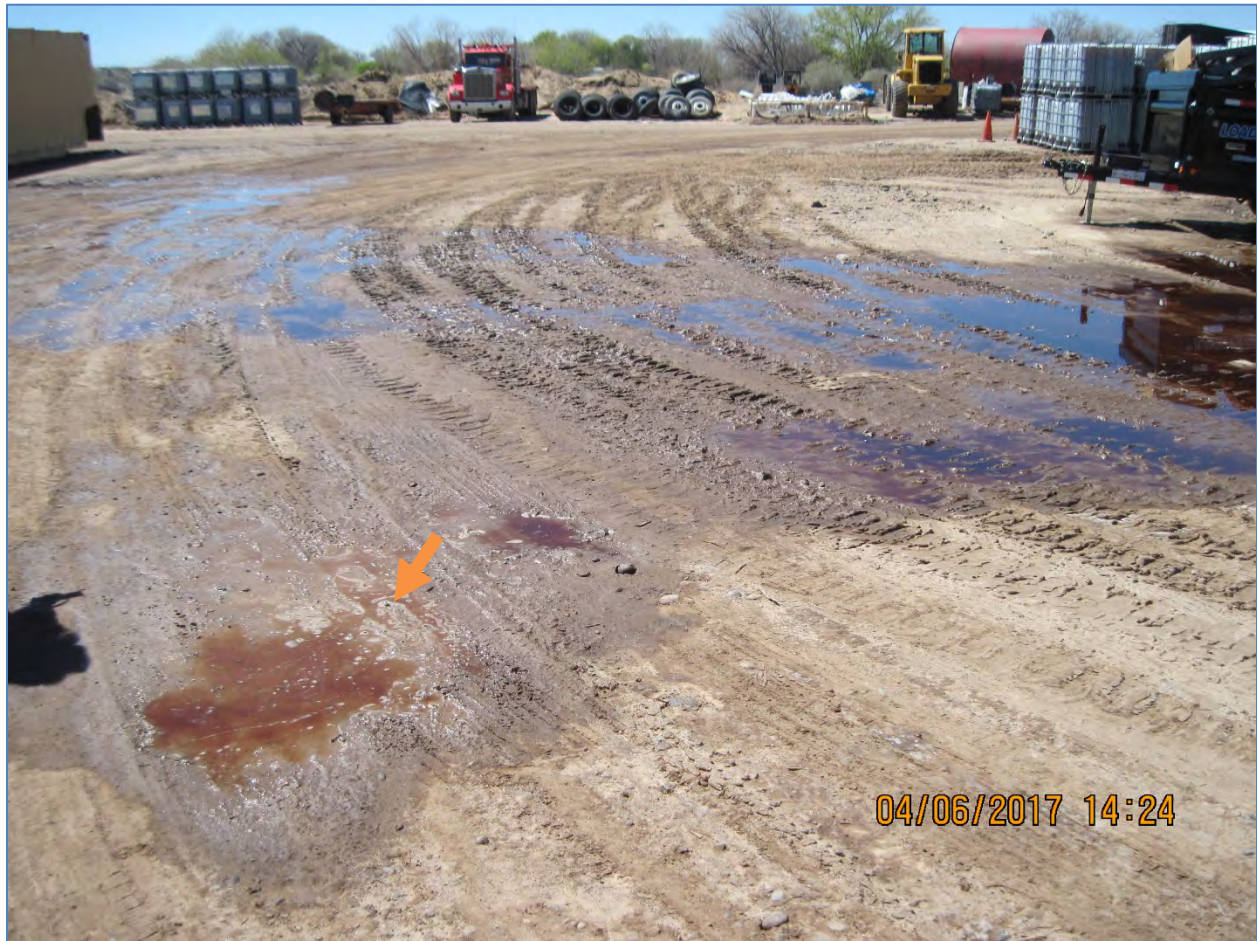
NMED/SWQB		
Official Photograph Log		
Photo # 15		
Photographer: Erin S. Trujillo	Date: 04/06/2017	Time: 1424 hours
City/County: Kirtland, New Mexico / San Juan County		State: New Mexico
Location: Desert Mountain Corporation		
Subject: From central portion of site looking west, arrow points to example of brown liquid south of the product loading area.
